**THE CALIFORNIA EARTHQUAKE OF APRIL 18, 1906**

**REPORT**

**OF THE**

ANDREW C. LAWSON

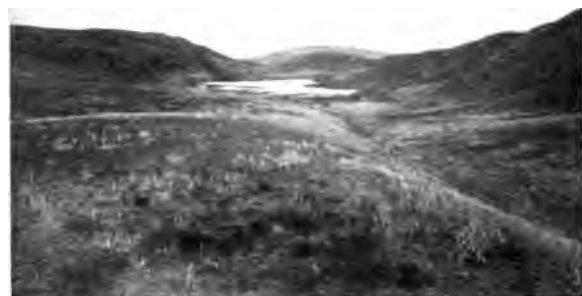
E. Rift, just beyond southeast end Carissa Plain. A. C. L., Jan., 1906.

A gentle divide separates the southern end of the Carissa Plain from a long narrow sink extending along the Rift line toward the southeast. (Plate 21D, E, F.) This sink includes an area 6 miles long and in places its drainage is fully 3 miles wide. Several depressed alkali flats, covered with water during the wet season, receive the scanty run-off of this dry region. These depressions are several hundred feet wide and are bordered upon opposite sides by quite sharp bluffs, in some places 100 feet high. The phenomena suggest the sinking of long narrow blocks between two walls. This reach of 6 miles between the ranches of Job and Emerson is one of the most interesting areas examined. The larger scarps belong to some ancient disturbance, while the last one, probably dating from 1857, is marked by features comparatively insignificant.

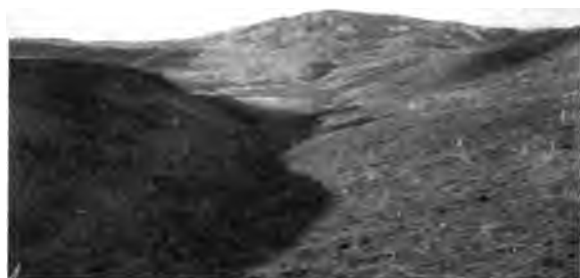
F. Rift, just beyond southeast end Carissa Plain. A. C. L., Jan., 1906.

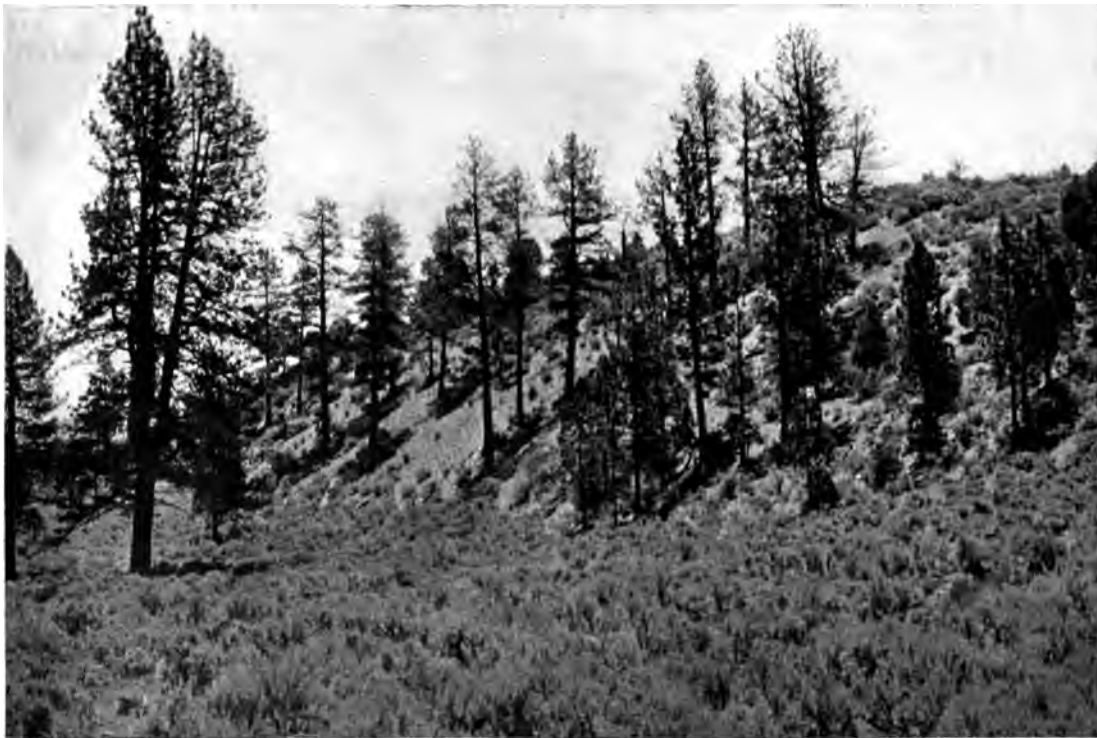
B. Old fault-scarp in Rift. East end of Cuddy Valley. H. W. F.

(See plate 22B.) The fissure follows its northern side for several miles and then, bending a little toward the south, crosses the canyon and takes a course for Tejon Pass. The granitic mountains upon the north of the canyon rise with exceedingly steep slopes, the rocks of which have been thoroly shattered. Immense quantities of rock débris have been brought down the gulches, building up in the main canyon a succession of large and steep débris fans. So much débris has been carried down the canyon that it has been blocked at the point where it turns toward old Fort Tejon, and has thus given rise to Castac Lake. The Rift crosses the divide at the gap known as Tejon Pass. Here there are features due to two movements. Descending a few hundred feet, we find ourselves in a long valley, extending about 10 miles in a direction a little south of east. Springs, marshes, and two ponds mark the line of the Rift from Gorman Station easterly. (Plates 23B and 24A.)

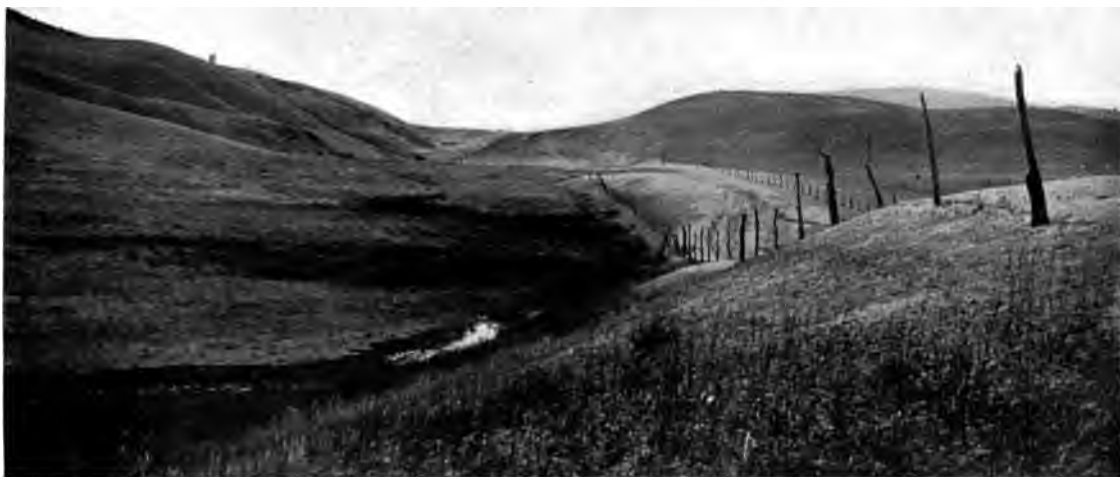
B. Looking east along the Rift from Gorman Station. The low scarp was probably made in 1857. H. W. F.

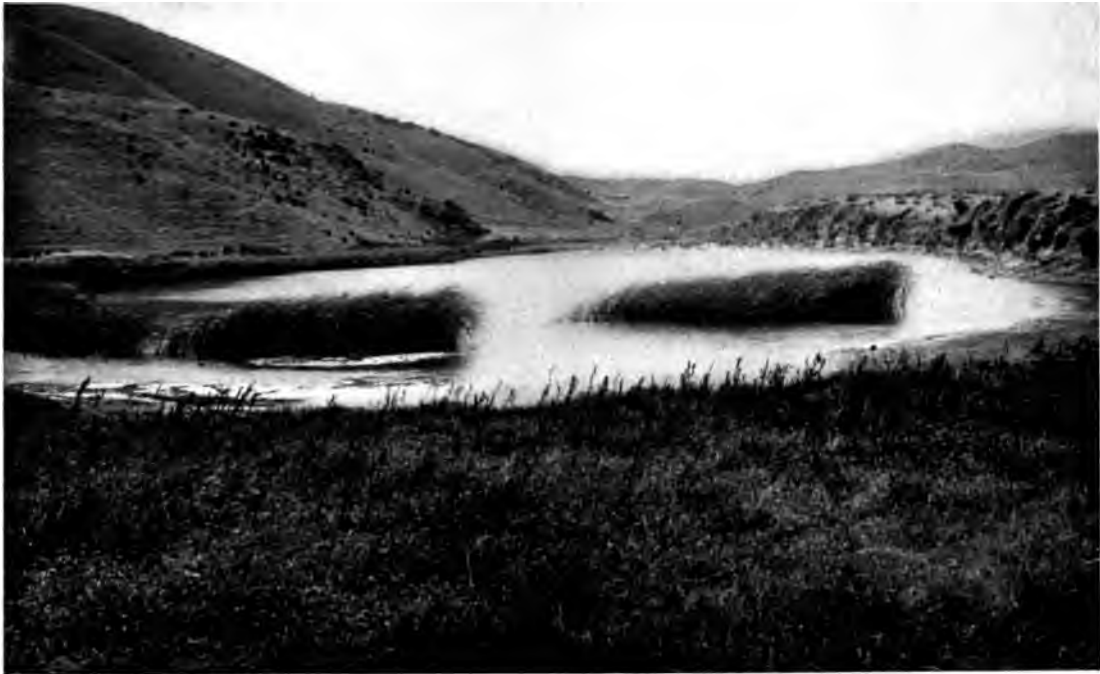
A. Pond and scarp in Rift east of Gorman Station. H. W. F.

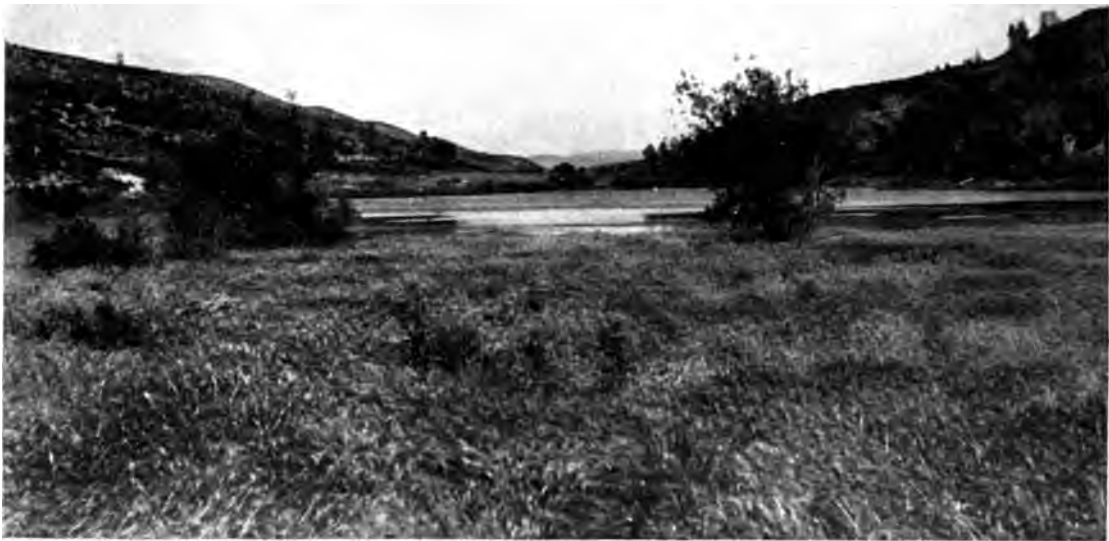
B. Lower Lake Elizabeth. In the Rift. H. W. F.

Lake Elizabeth and Lower Lake (plate 24B) are both due to the blocking of the drainage of two valleys extending along the Rift. These valleys lie on the slope of the range toward the desert (Antelope Valley), but their outlet is southward by a narrow canyon thru the heart of the mountains lying between the desert and Santa Clara River. A low escarpment along the southern side of the valley in which Lake Elizabeth lies, and eastward, is replaced by a lofty rounded ridge which appears to be due to some one of the movements along the old fault. For several miles east of the lake (plate 25A) the distinctive and characteristic features of the Rift are not as easily made out, altho the ridge just mentioned is full of springs and exhibits a widespread landslide topography. Toward the eastern end of this ridge small hollows and a low, indistinct escarpment again appear. The ridge separates Leones Valley, a fertile and well-watered district 5 or 6 miles long, from the open Mojave desert on the north.

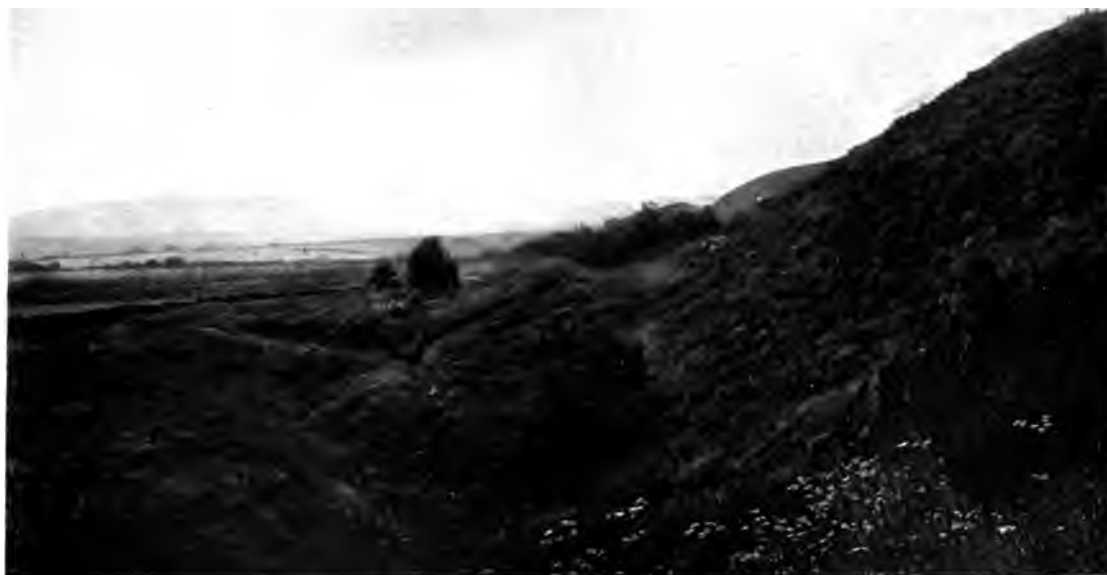
B. Double fault-scarp in Rift north of Highland, at base of San Bernardino Range. H. W. F.

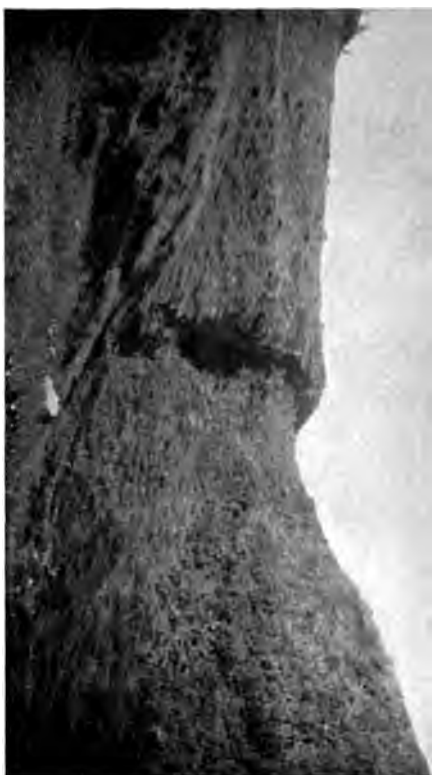
characteristic little gap or saddle (plate 31A), and south of *B* follows closely an old fault line, with a slight upthrow on the west. North of the road the fault-trace follows a ravine for some distance, then passes along the west side of a low ridge, as indicated in the contouring, and finally drops down to Humboldt Creek. Thence it ascends the

A. Fault-scarp passing thru saddle at head of Wood Gulch, looking south-southeast.  
F. E. M.

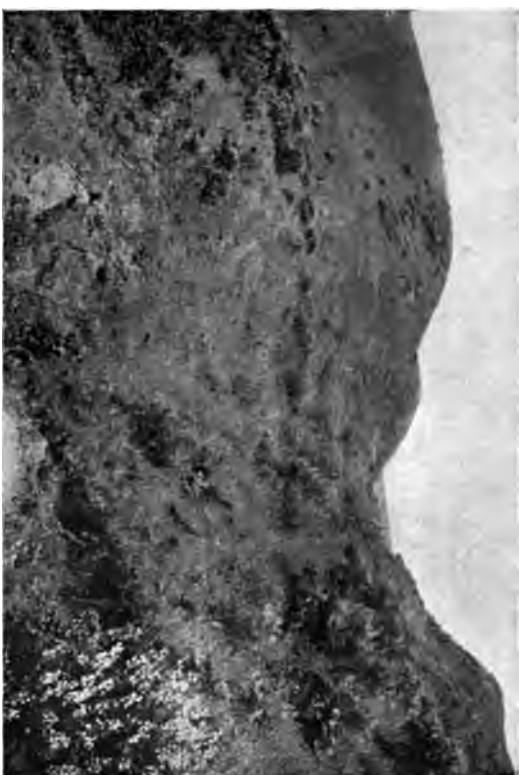
B. Auxiliary fault-trace following old scarp in saddle between Wood Gulch and Humboldt Creek. F. E. M.

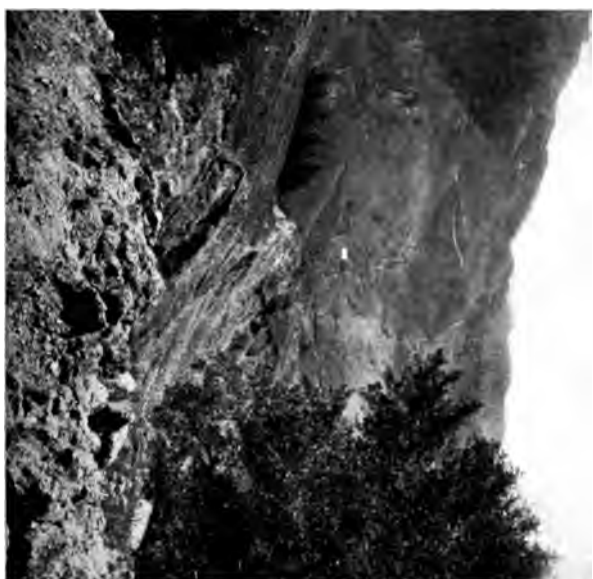
C. Looking south-southeast from Telegraph Hill along fault-trace marked by sharp-crested ridge in foreground, with upthrow of 4± feet. F. E. M.

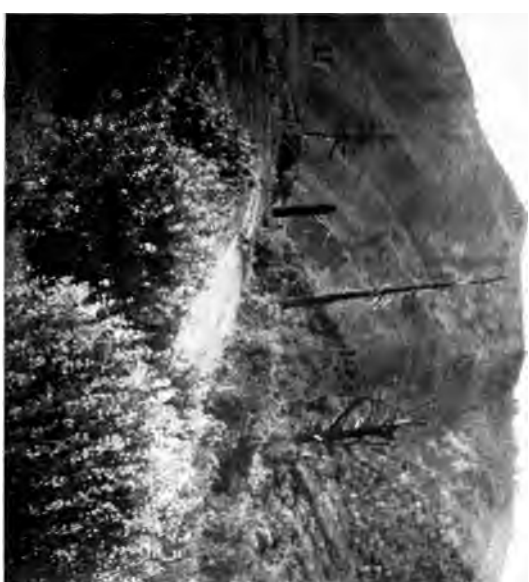
D. Looking north-northwest along main fault marked by small ridges on spur of Telegraph Hill. F. E. M.

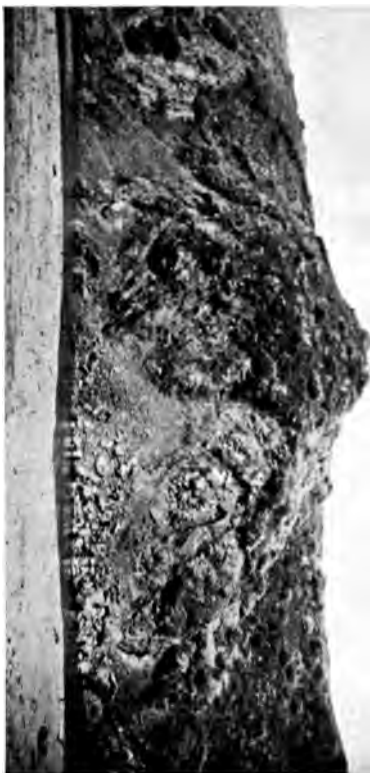
A. Rocky stream cliff 50 feet high on north side of Alder Creek. Fault vertical on left of knoll; auxiliary fault on right of knoll. F. E. M.

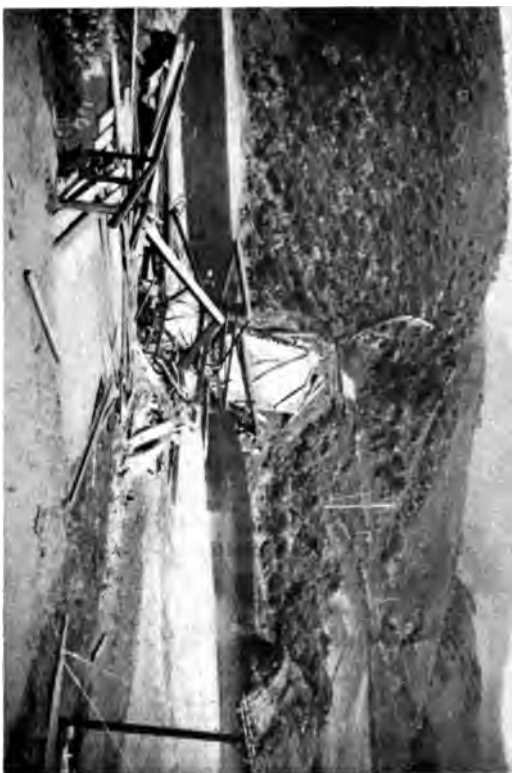
Southeast of this point, the fault-trace follows the broad stream bed of Alder Creek for nearly a mile, passing beneath a bridge, the wreck of which is shown in plate 32B. In this view, the horizontal offset of the bridge along the fault-line is well shown. It is apparent that this offset is not less than the width of the bridge. On the southwest side of the stream, near the bridge (A, fig. 12), the fault-trace is flanked by peculiar, isolated, rocky knobs similar to that on the northeast side. It is not clear, however, that these rocky knobs have more than an accidental relation to the fault, since they may possibly be residual sea-stacks upon the uplifted wave-cut terrace.

B. Fault passing under bridge over Alder Creek. Bridge displaced not less than its width. F. E. M.

The wagon bridge over Alder Creek (plate 32B), which stood astride of the fault, is a complete wreck. The timbers broke in many places, and the tension rods were twisted and in some cases actually ruptured.

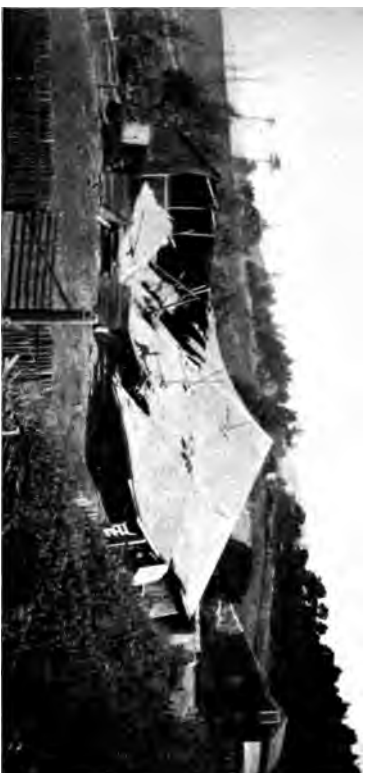
C. Barn of E. E. Fitch, north of Manchester. Astride the fault. F. E. M.

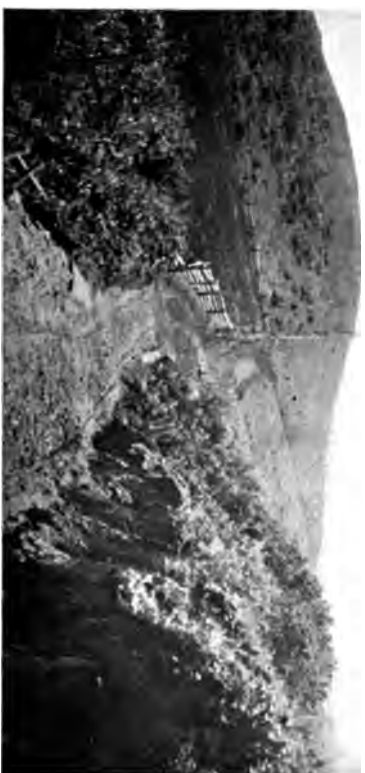
the zone of dislocation being in low, marshy ground. At another place near Manchester, where an east and west fence follows the north side of a wagon road, both fence and road have been offset as shown in plate 32d. In both cases the relative movement on the southwest side was to the northwest. The dairy barn on the ranch of Mr. E. E. Fitch stood astride the line of movement and was demolished by the torsion to which it was subjected. The wreck of the barn is shown in plate 32c. At two places along the stretch between Alder and Brush Creeks the bearing of the fault-trace was measured, the readings being N. 28° W. and N. 30° W.

D. East-west fence 0.25 mile north of Manchester offset by fault. Fence and road were formerly straight and have been repaired. Looking east. F. E. M.

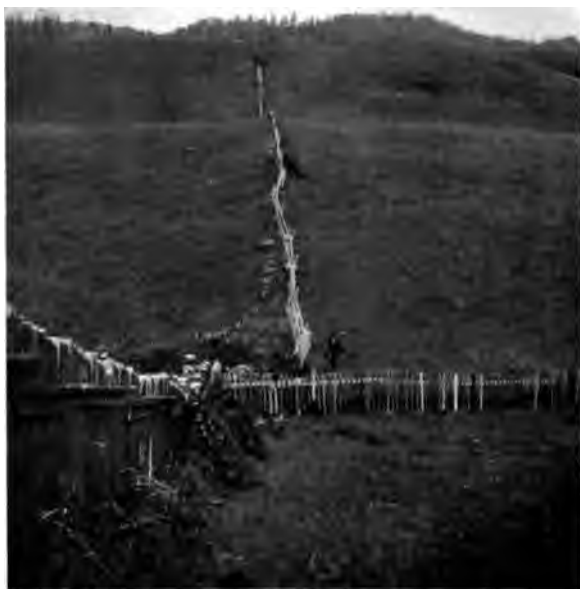
A. East-west fence near saddle between Garcia River and Brush Creek. Main offset 13 feet. Auxiliary offset 2.5 feet in middle ground. F. E. M.

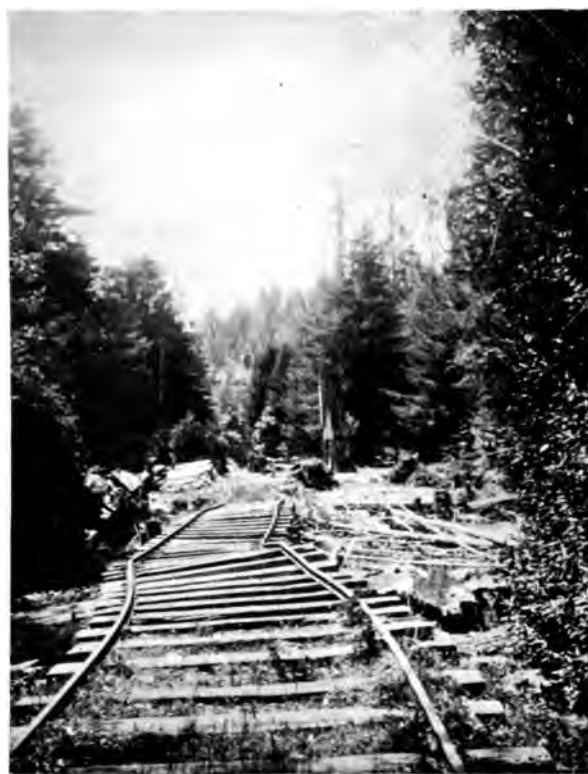
B. Small railway trestle, Little North Fork Gualala River, looking north. Main fault-trace 100 feet to right. Auxiliary crack under trestle. F. E. M.

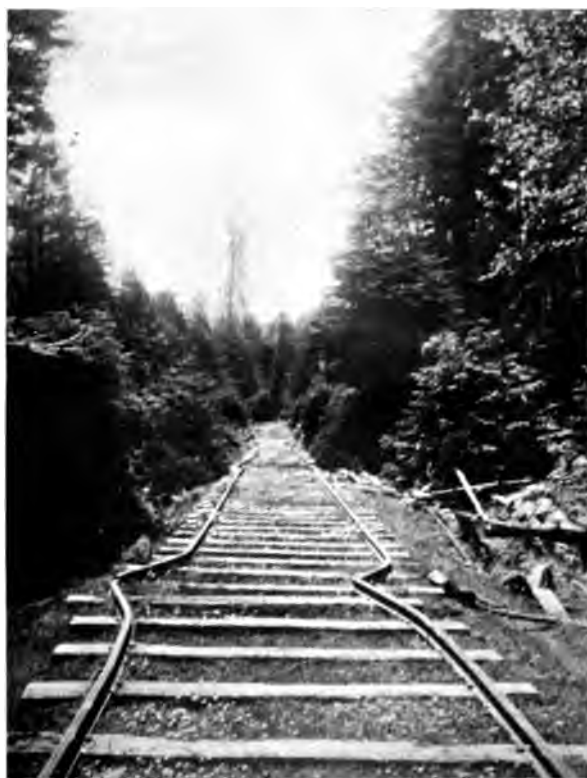
C. Buckled track, Little North Fork Gualala River. Both rails broken. Fault-trace parallels track 50 feet to left. F. E. M.

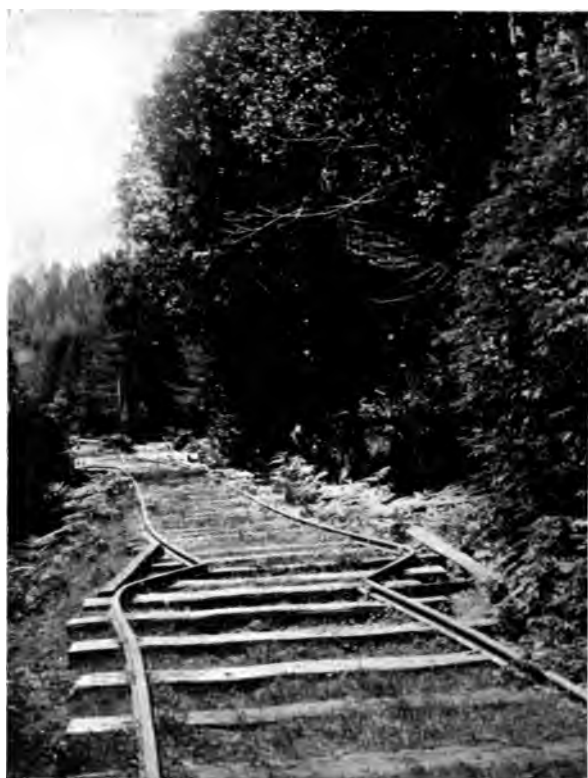
D. Buckled track, Little North Fork Gualala River. Fault-trace 100 feet to left. F. E. M.

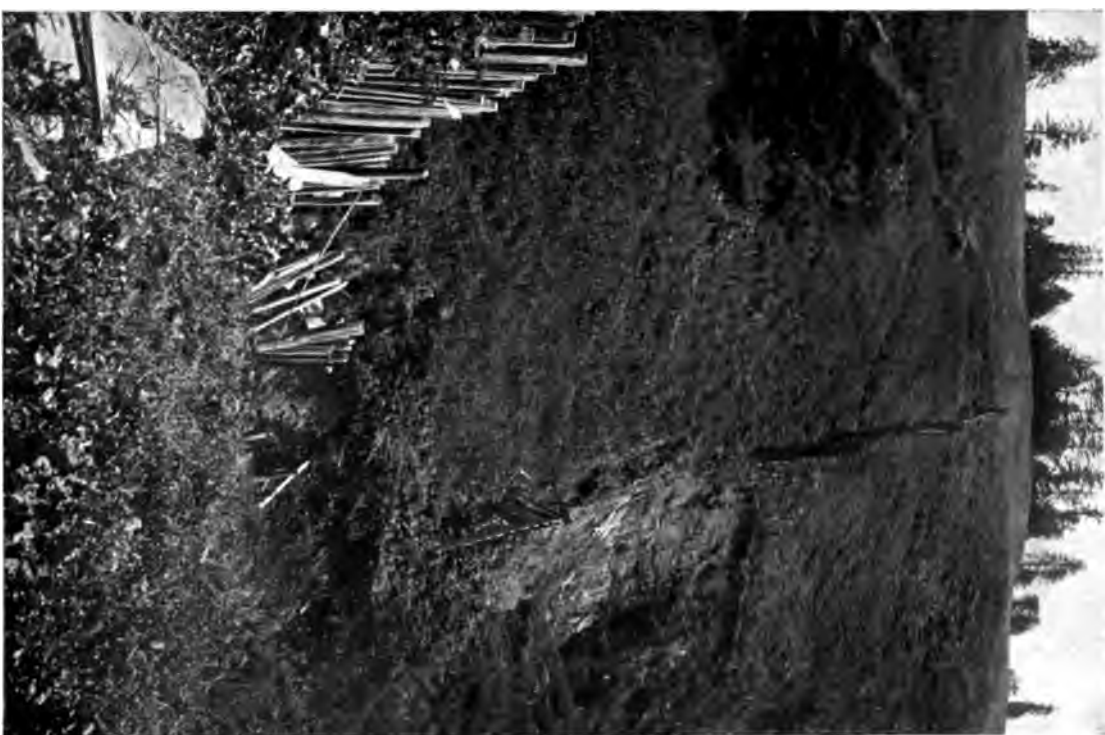
B. Dislocation of fence near Fort Ross, J. N. L.

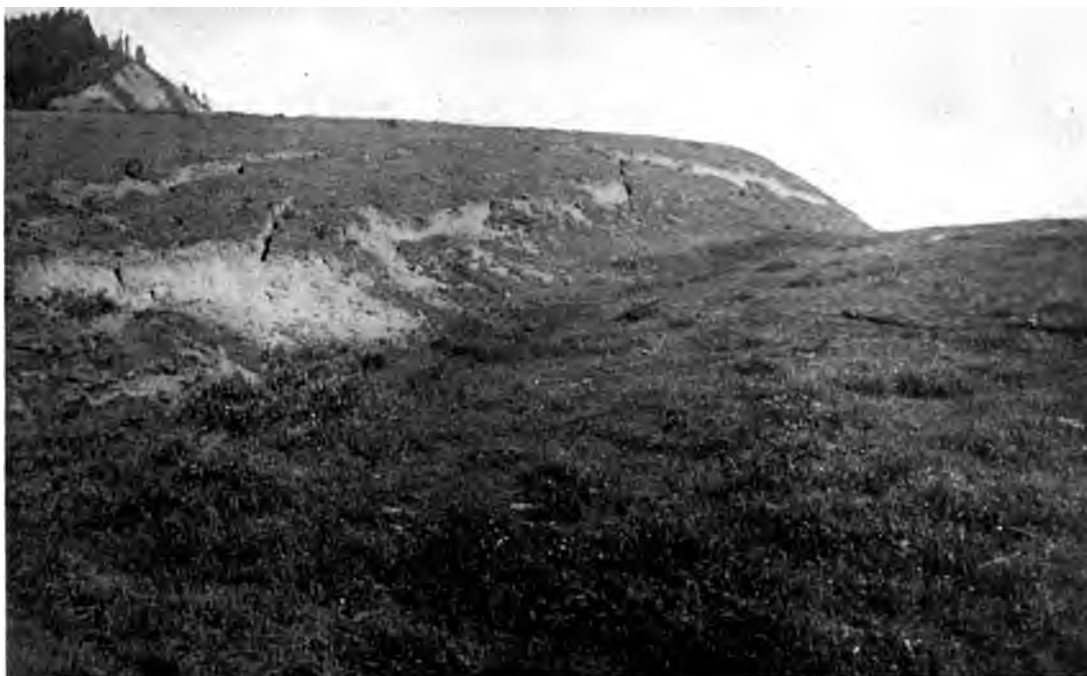
A. Accentuation of old scarp by new fault 1.5 miles north of Fort Ross. J. N. L.

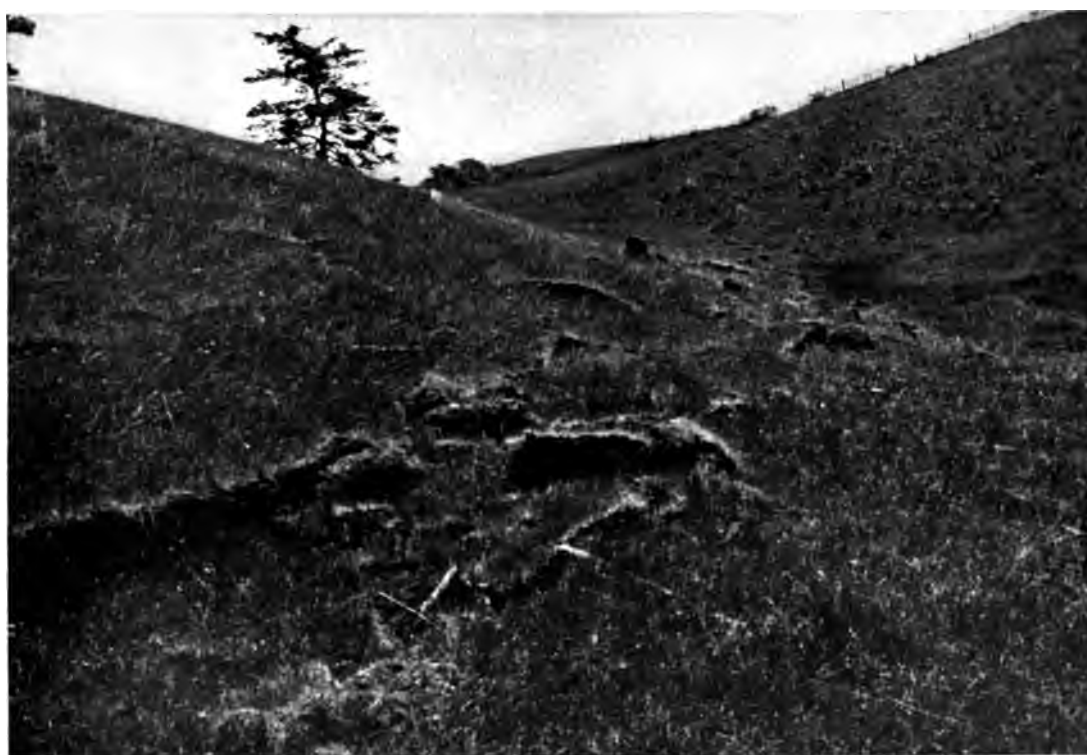
B. Fault-trace on grass-covered slope near Fort Ross. R. L. H.

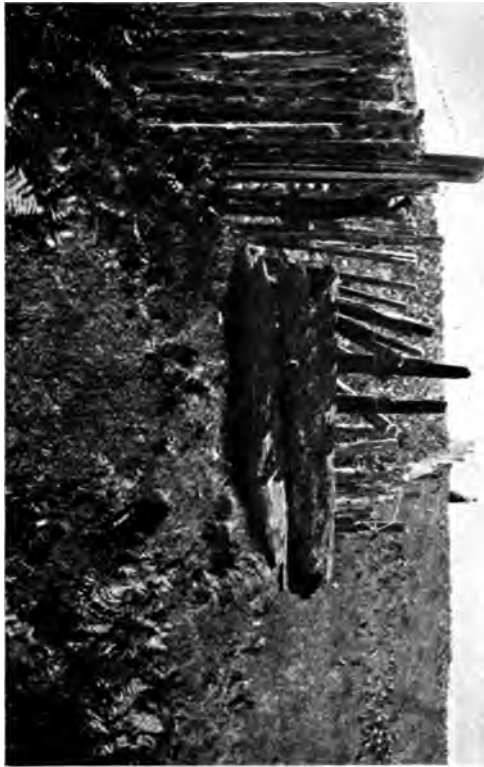
A. Offset of 8 feet on fence a mile east of Fort Ross. R. S. H.

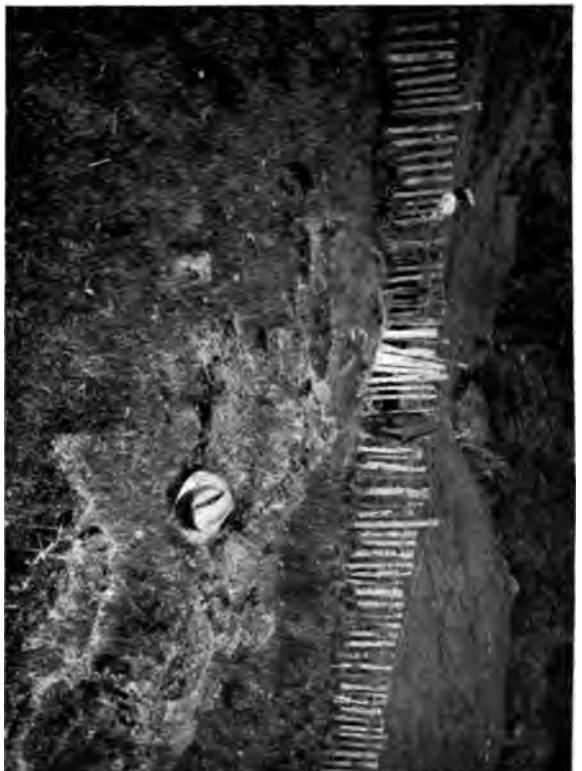
B. Fault-trace and dislocated fence near Fort Ross. R. S. H.

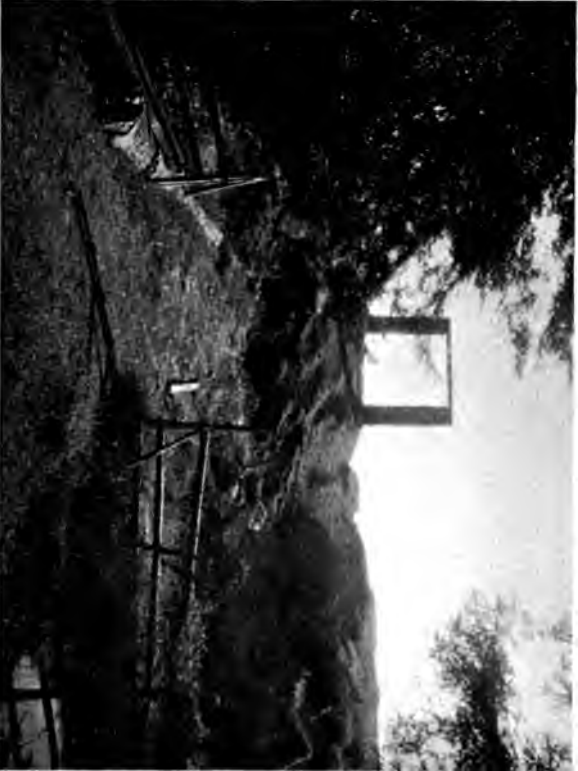
C. Roadway offset 12 feet. New fault-scarp 3 feet high, facing northeast. Above Fort Ross. F. E. M.

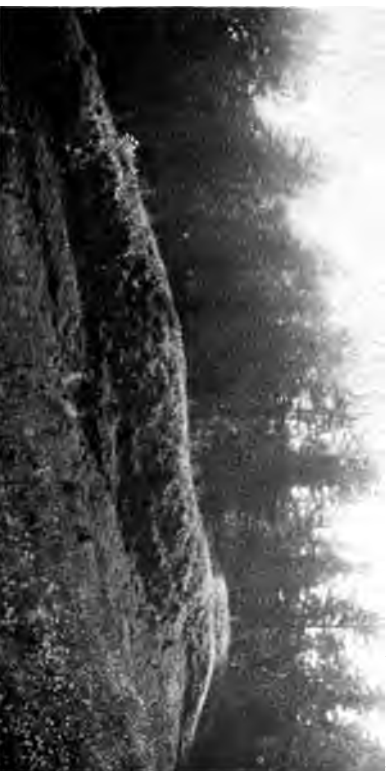
D. Accentuation of old fault-scarp by new fault. Near Fort Ross. F. E. M.

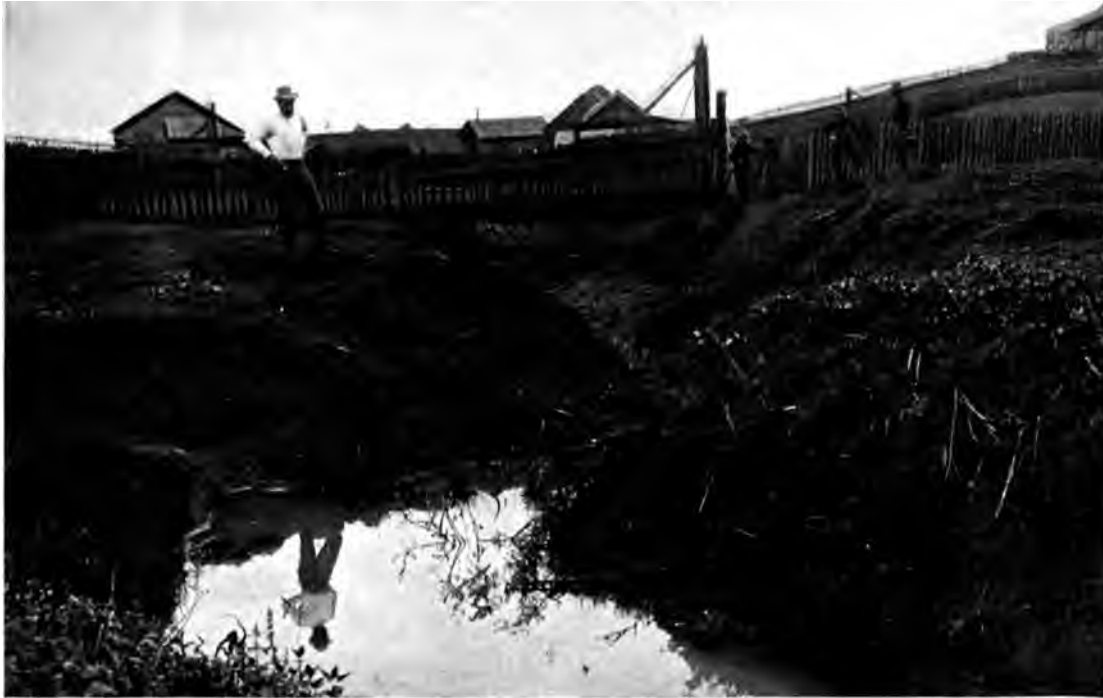
A. Offset of stream trench by the fault and ponding of water by the fault-scarp. Doda's ranch, a mile southeast of Fort Ross. A. C. L.

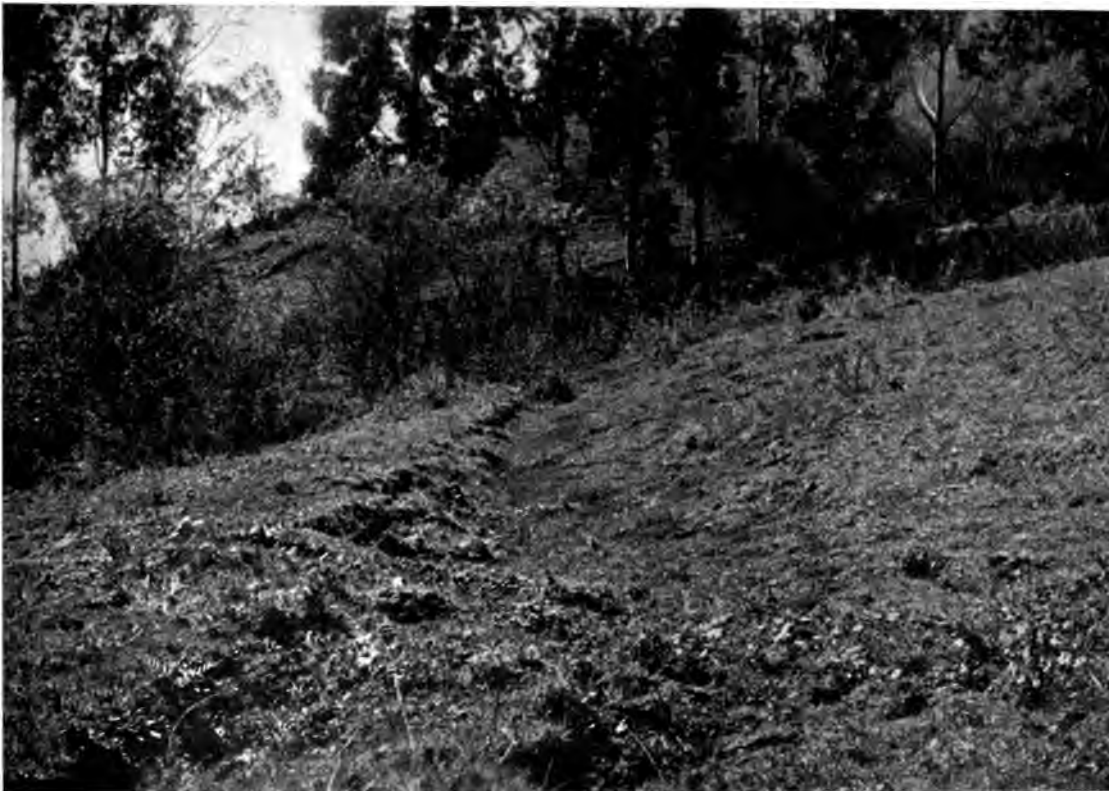
B. The fault-trace a mile northwest of Bolinas Lagoon, looking southwest. Illustrates the ridge phase. G. K. G.

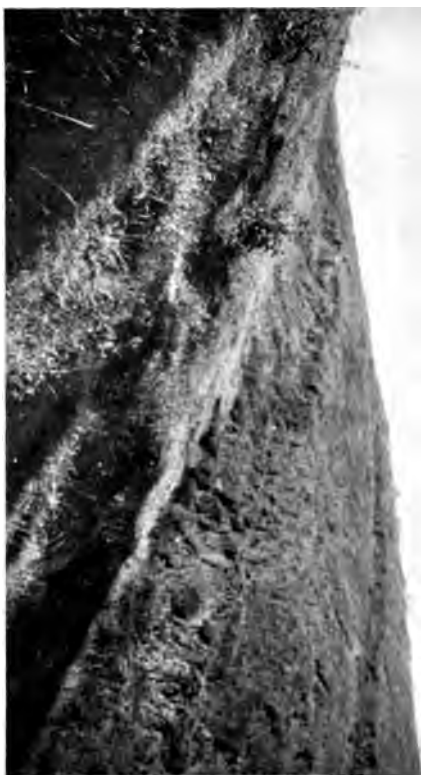
A. Fault-trace in old depression marked by scarp 3 ± feet high, with auxiliary scarp above. Doda's ranch, a mile southeast of Fort Ross. Looking southwest. F. E. M.

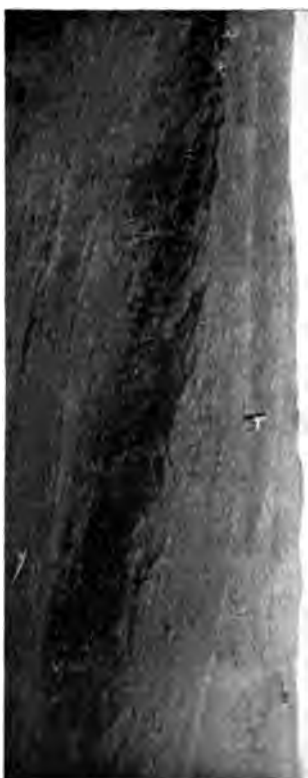
B. Fault-trace marked by scarp 3 ± feet high on west side. Southeast of Fort Ross, looking southwest. F. E. M.

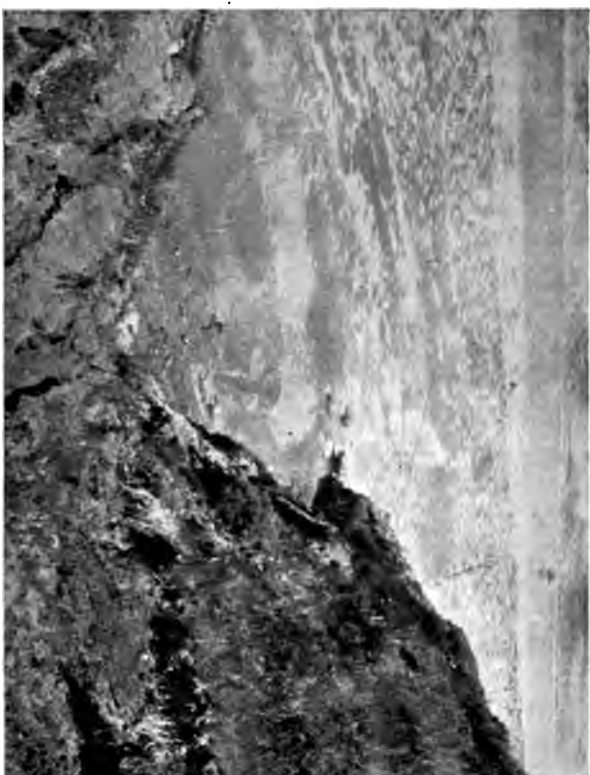
C. Fault-trace extending from cliff in foreground across tidal flats of Tomales Bay, near its mouth. R. S. H.

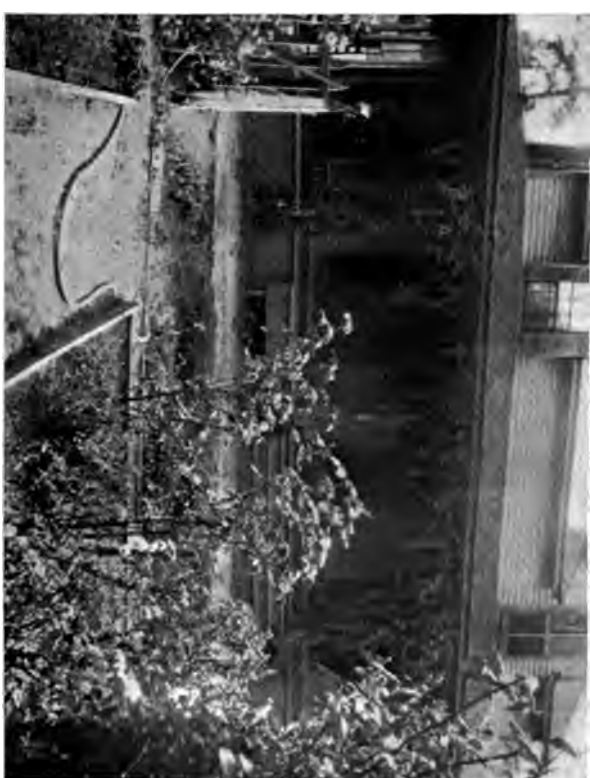
D. Fault-trace between garden and house, Skinner's ranch, near Olema. Before earthquake center lines of path and steps were coincident; afterwards offset was 15 feet 9 inches.

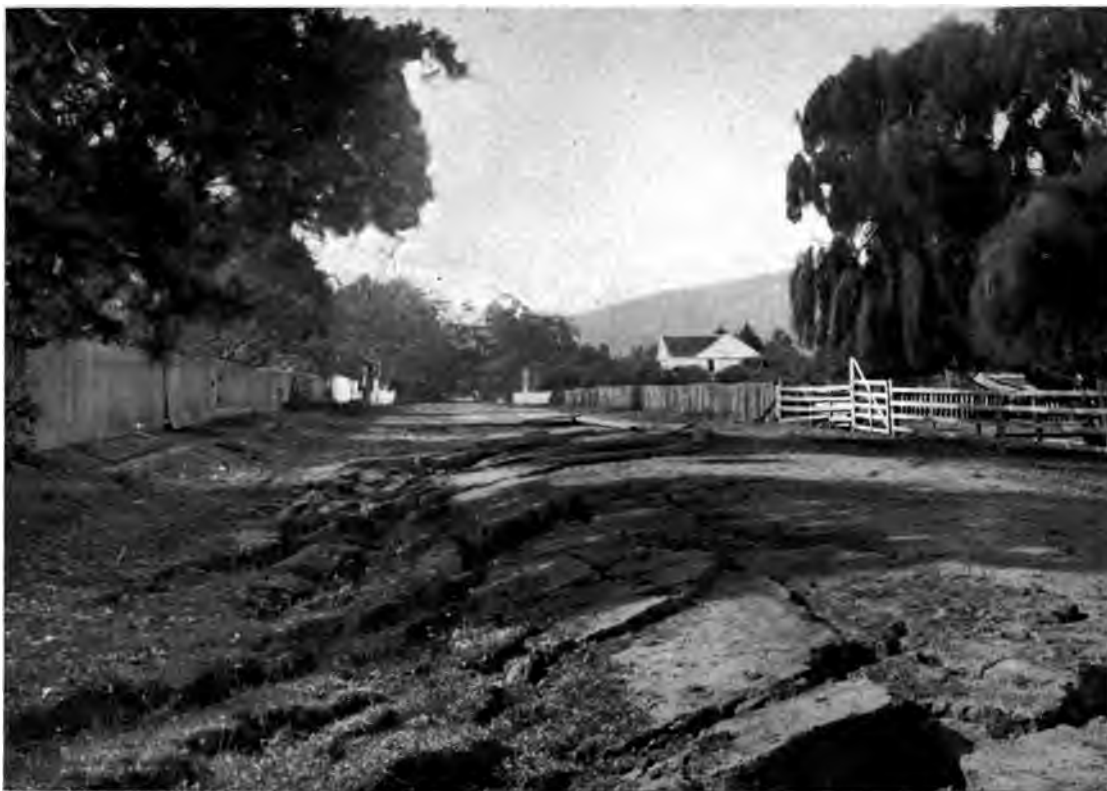
A. Branch of fault-trace in north part of Bolinas. Looking north-northwest. Illustrates diagonal cracks. G. K. G.

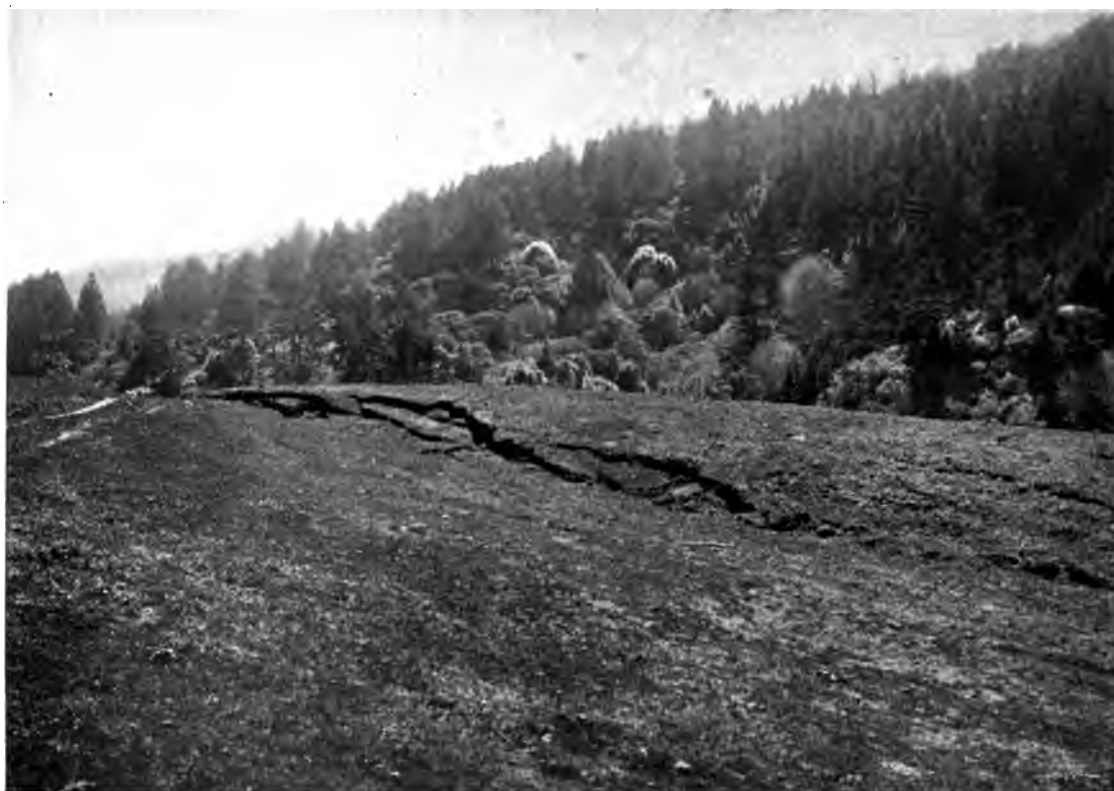
B. Branch of fault-trace, near Bondietti's ranch. Looking south. Illustrates diagonal cracks. G. K. G.

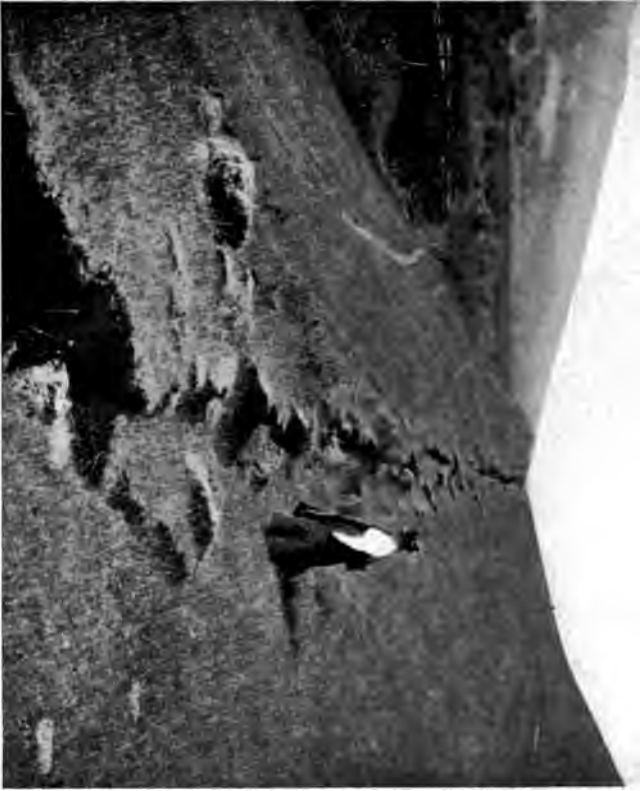
A. Fault-trace a mile north-northwest of Olema. Looking northwest. Illustrates ridge phase. G. K. G.

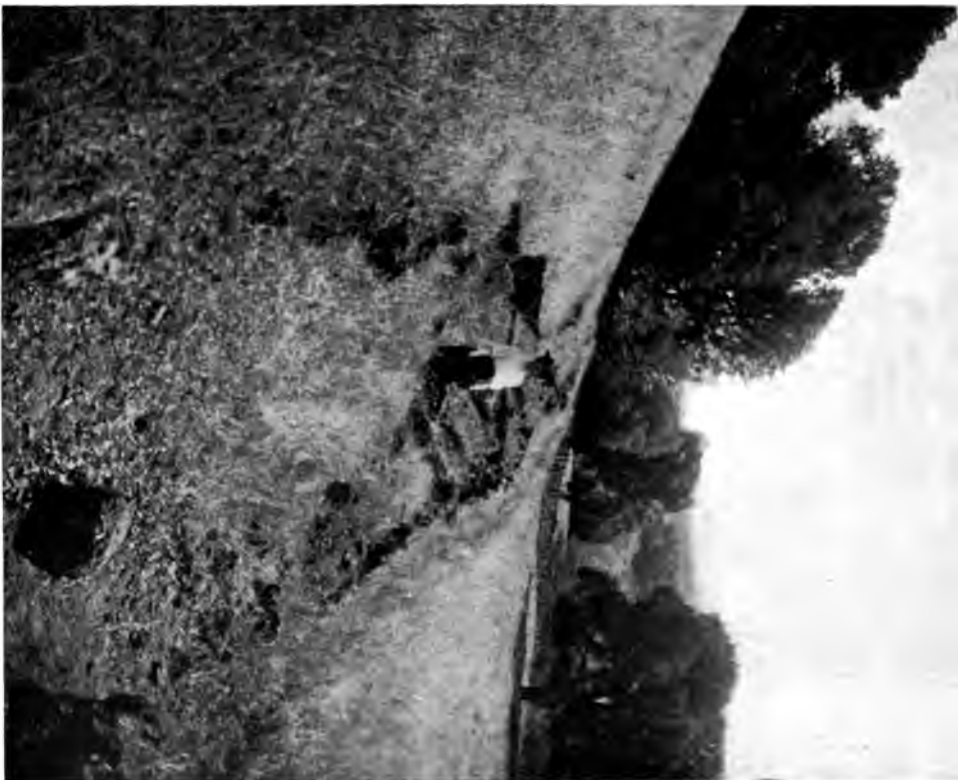
B. The fault-trace west of Olema. Looking southeast. Illustrates the trench phase. G. K. G.

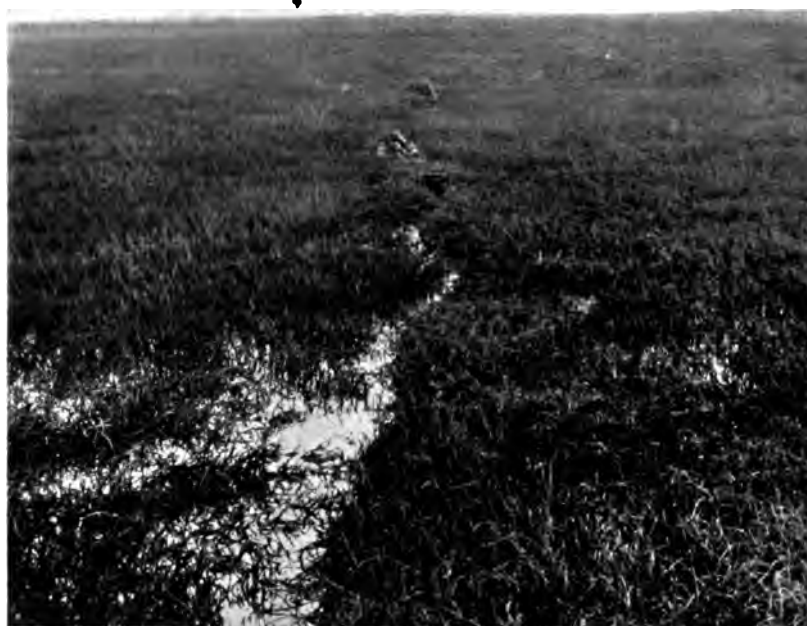
A. Looking southeast on Pepper Island. In the foreground the fault-trace is central. It trends toward the distant +. G. K. G.

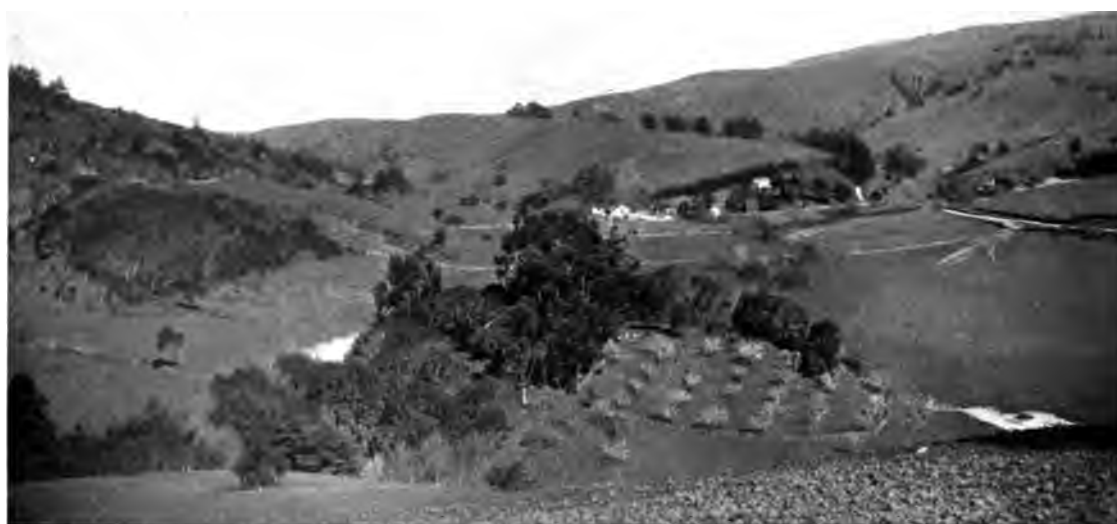
B. Looking north from hill west of Woodville. From buildings (Strain ranch) a large rift ridge runs northwest between 2 fault-sags. The western sag is followed by Pine Gulch Creek. Fault-trace runs from right of pond in foreground to left of buildings and follows sag for a mile, gradually crossing it. G. K. G.

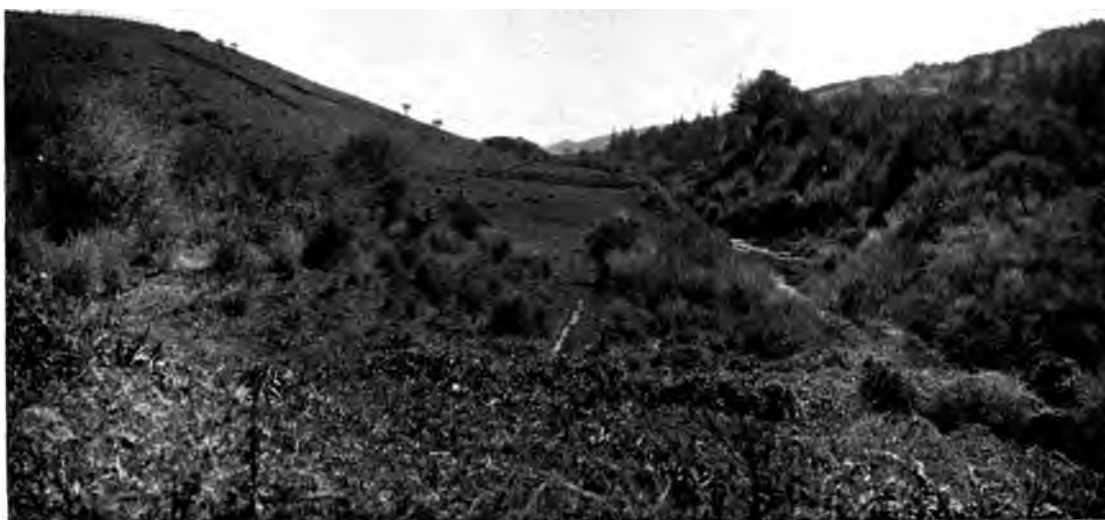
A. Sag followed by fault-trace a mile north of Strain ranch. Looking southeast. Trace, concealed by bushes, runs near ponds. G. K. G.

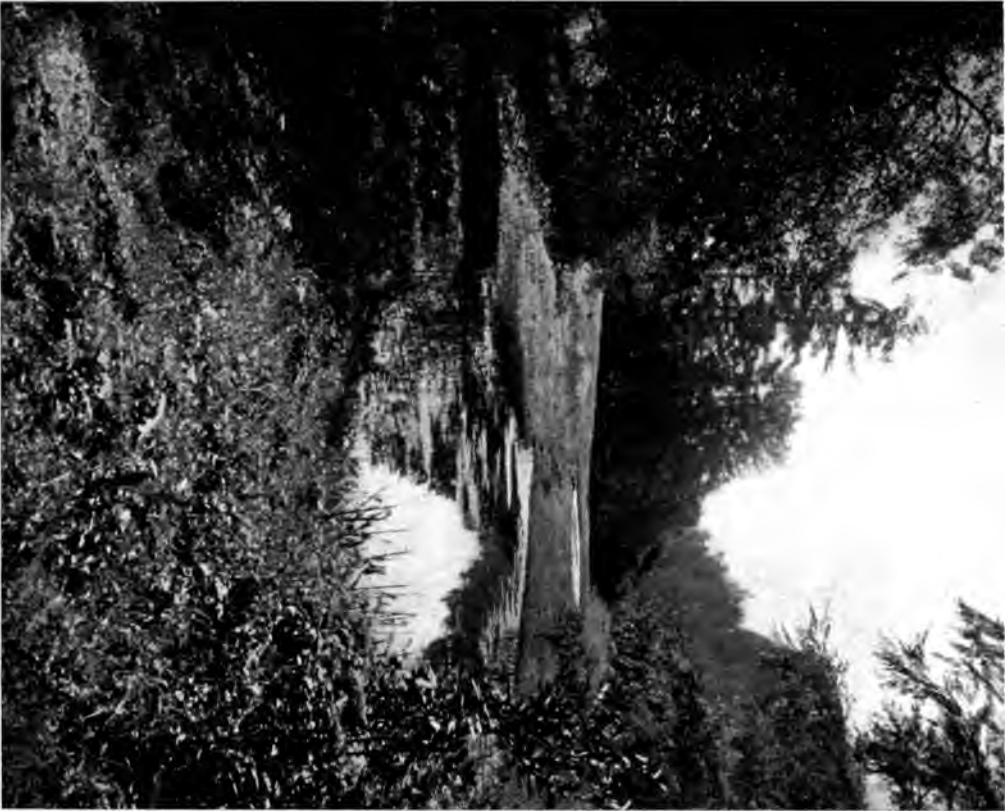
B. Looking southeast from point near Shafter's ranch, Olema. Fault-trace follows base of hill and includes water-filled depression. G. K. G.
